REPORT NO. 06-04F

**EVALUATION TRANSPORTABILITY TESTING OF THE
JOINT MODULAR INTERMODAL PLATFORM (JMIP) UNIT #4
TP-94-01,
“TRANSPORTABILITY TESTING PROCEDURES”**

**DEFENSE AMMUNITION CENTER
VALIDATION ENGINEERING DIVISION
MCALESTER, OKLAHOMA 74501-9053**

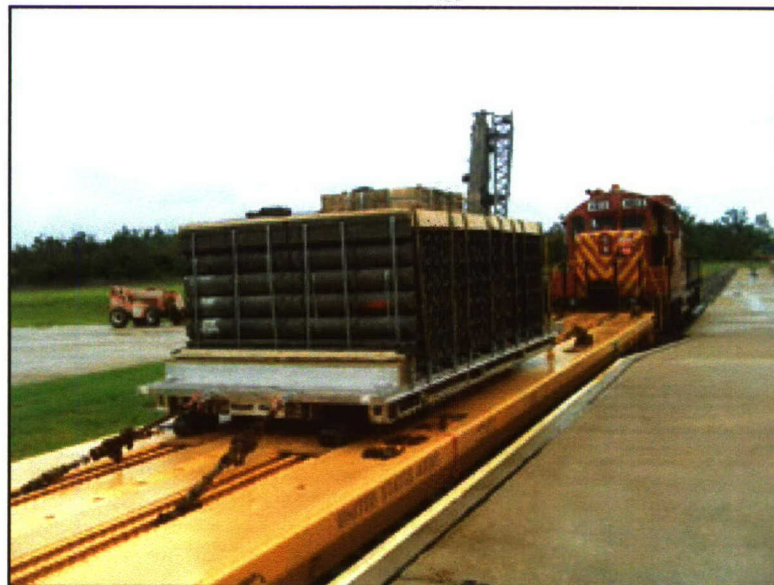
Photo 1. Rail Impact Testing of the JMIP (Prior to Testing)

Description	Weight
Flatcar Number: DODX 42353	85,000 lbs.
JMIP	24,880 lbs.
M1 Flatrack with MLRS Pods	28,265 lbs.
Total Specimen Wt.	138,145 lbs.
Buffer Car (four cars)	257,900 lbs.

Remarks: Figure 4 lists the test components and weights of the items used during the Rail Impact Tests.

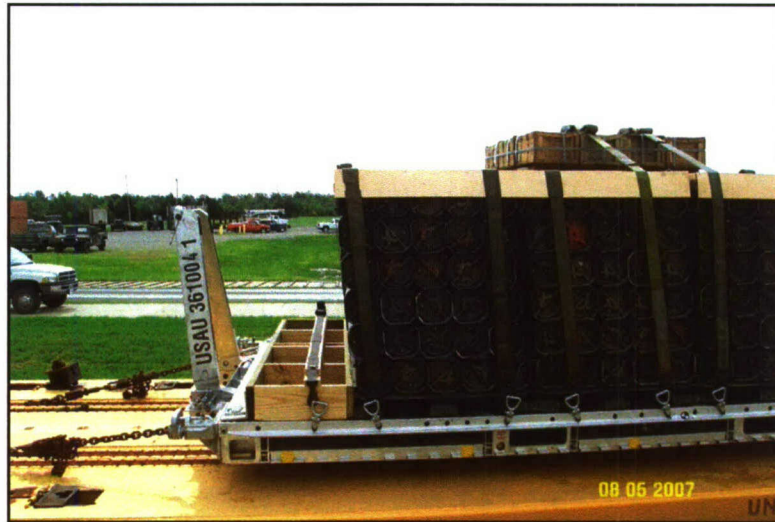
Photo 2. Rail Impact Testing of the JMIP (Following Impact #4)

1. Figure 5 lists the average speeds of the specimen car immediately prior to impact with the anvil. Impact #4 is the reverse impact.
2. The JMIP was secured directly to the railcar for testing.
3. Following Impact #1, the payload compacted in the direction of impact 1.25 inches.
4. Following Impact #3, the payload racked and the top pallet moved in the direction of impact.
5. Following Impact #4, the dunnage at the non-bail-bar end of the JMIP moved 0.25 inches. The end gate was no longer vertical and had moved up 0.5 inches from the JMIP deck.
6. Following Impact #4, the payload had moved excessively and was no longer safely and properly positioned on the pallets. The end of the payload did not have cross straps. The testing was stopped and the JMIP was unloaded. See Photo 2.

1. Initially, forward and aft web restraints (crossing straps) were not used on each end of the payload. Following the reverse rail impact, the pallets and load moved excessively. The testing was stopped. Retesting included forward and aft web restraints.
2. The full-width end gates were used to restrain the payload and did not successfully complete testing.

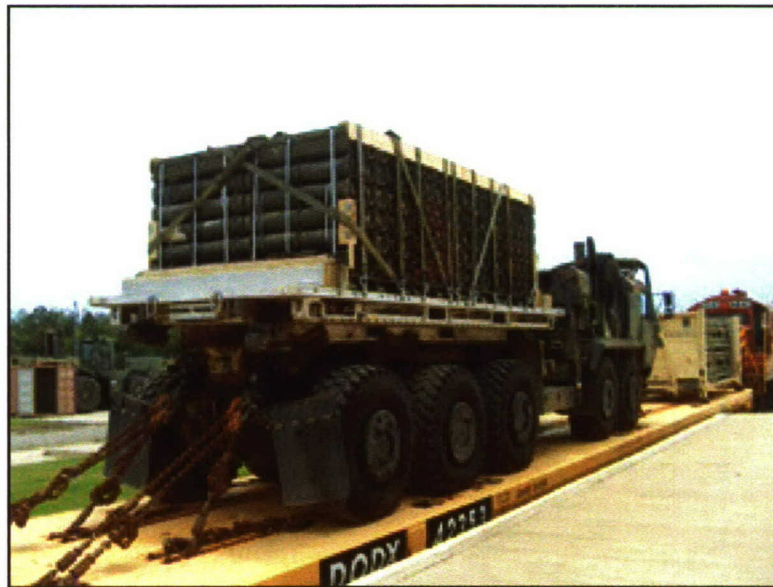
Photo 3. Rail Impact Testing of the JMIP (Prior to Testing)

1. Forward and aft web restraints were used at each end of the payload.
2. The rail transport pin holes on the JMIP aligned with the corresponding hole on the PLS truck. The rail impact testing was conducted with the JMIP on the PLS truck.

Description	Weight
Flatcar Number: DODX 42353	85,000 lbs.
PLS Truck with JMIP	75,380 lbs.
M1 Flatrack with MLRS Pods	28,265 lbs.
Total Specimen Wt.	188,645 lbs.
Buffer Car (four cars)	257,900 lbs.

Remarks: Figure 6 lists the test components and weights of the items used during the Rail Impact Tests.

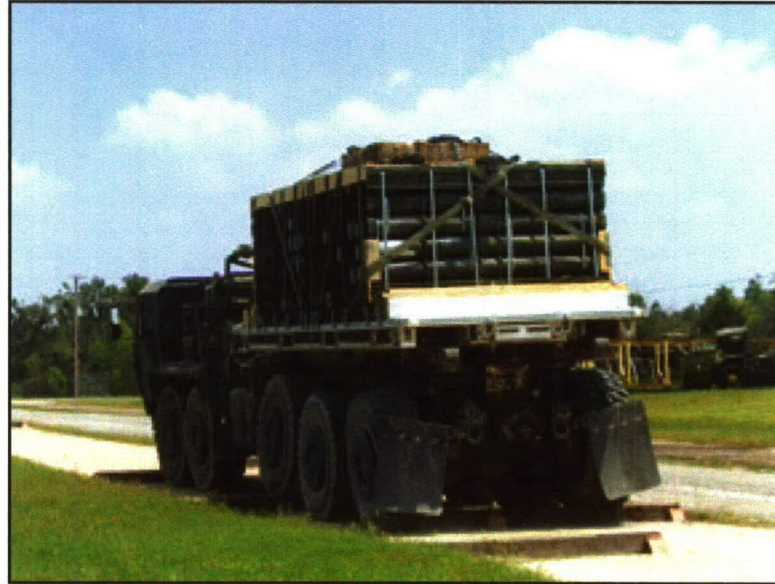
Photo 4. Hazard Course Testing of the JMIP

Pass No.	Elapsed Time	Avg. Velocity (mph)
1	22 Seconds	6
2	22 Seconds	6

1. Figure 8 lists the average speeds of the test load through the Hazard Course.
2. The JMIP was transported on the PLS truck.
3. Inspection did not reveal any damage to the JMIP.

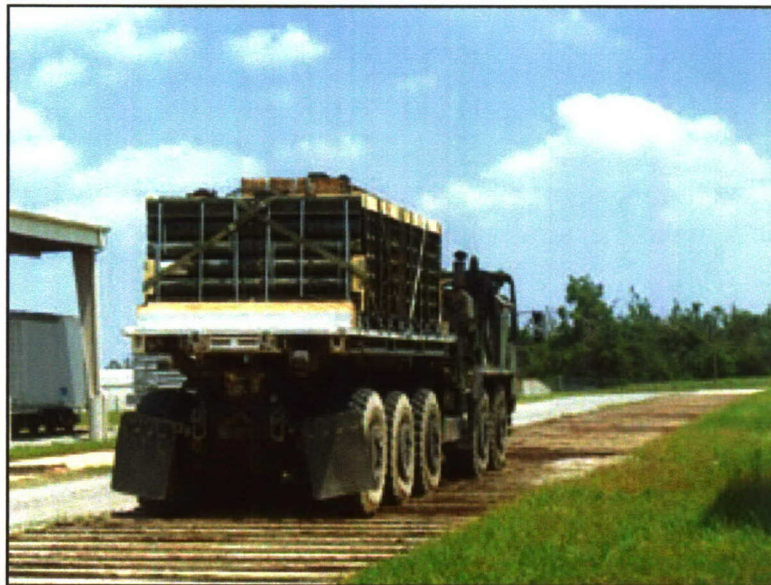
Photo 5. Washboard Course Testing of the JMIP

Remarks: Inspection following the Washboard Course revealed no damage to the JMIP.

C. OBSERVATION. The bottom plate on the main rail continues to deform and delaminate when the JMIP is loaded/unloaded onto/from the PLS truck.

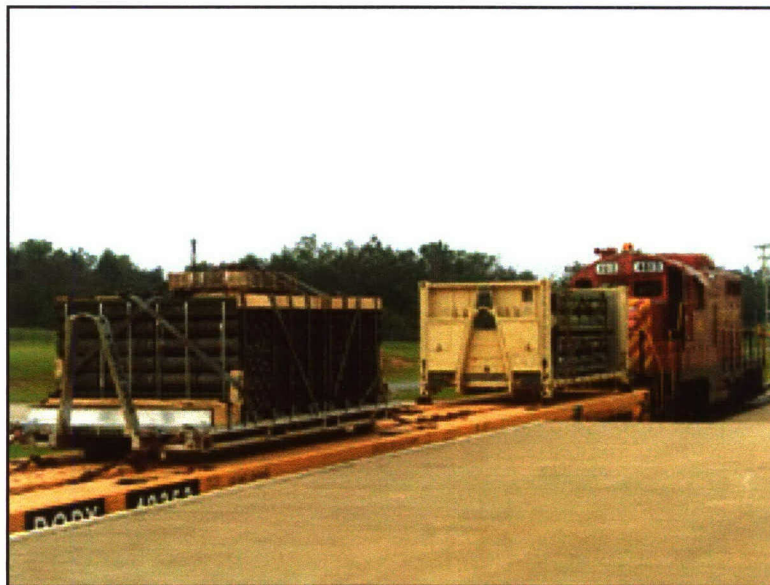
Photo 6. Rail Impact Testing of the JMIP (Prior to Testing)

Description	Weight
Flatcar Number: DODX 42353	85,000 lbs.
JMIP	25,220 lbs.
M1 Flatrack with MLRS Pods	28,265 lbs.
Total Specimen Wt.	138,485 lbs.
Buffer Car (four cars)	257,900 lbs.

Remarks: Figure 10 lists the test components and weights of the items used during the Rail Impact Tests.

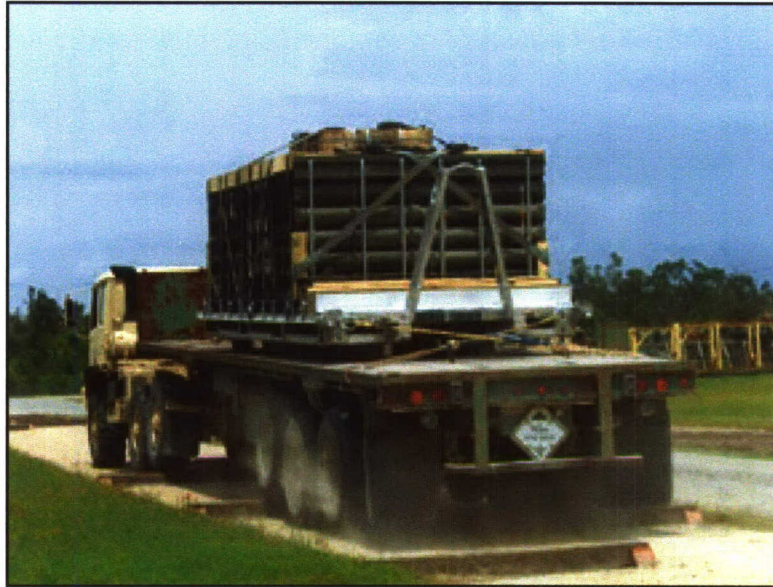
Photo 7. Hazard Course Testing of the JMIP

Pass No.	Elapsed Time	Avg. Velocity (mph)
1	24 Seconds	6
2	26 Seconds	6

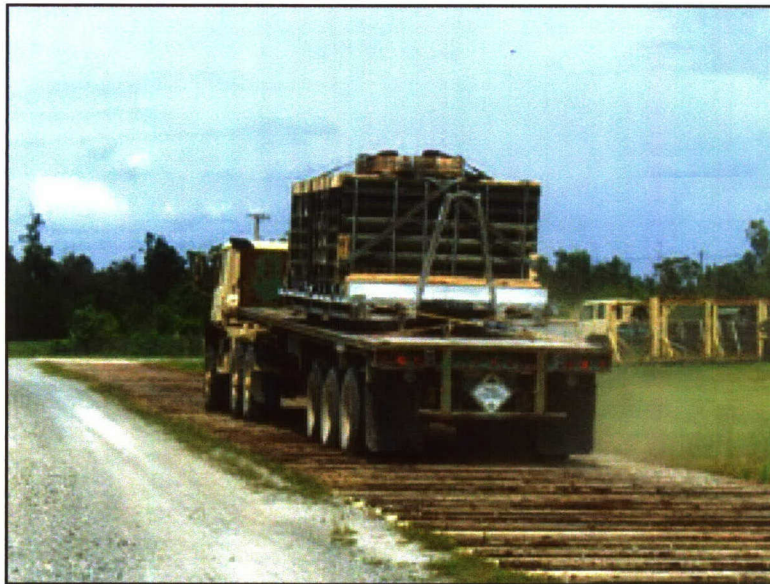
Photo 8. Washboard Course Testing of the JMIP

Remarks: Inspection following the Washboard Course revealed no damage to the JMIP.

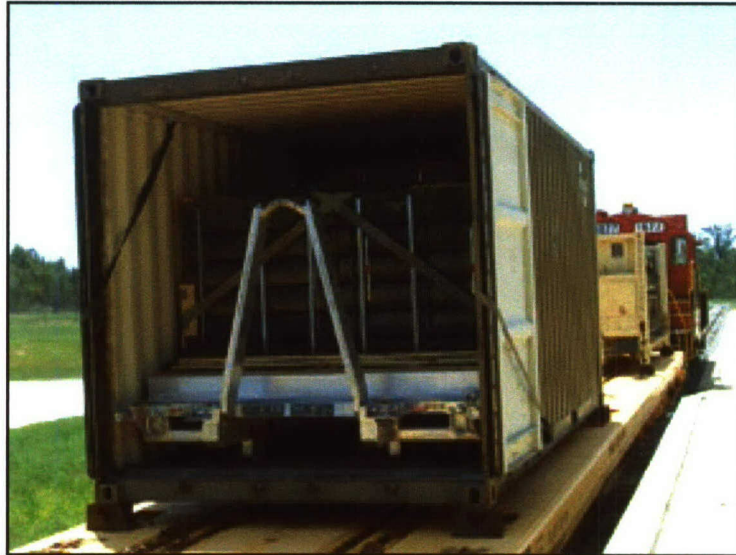
Photo 9. Rail Impact Testing of the JMIP (Prior to Testing)

1. Prior to the start of testing the hard plastic end bumpers were replaced with the softer rubber end bumpers.
2. When loading the JMIP into the intermodal container the point load caused by the JMIP side rail deformed the wall of the container.

Description	Weight
Flatcar Number: DODX 42353	85,000 lbs.
JMIP and intermodal container	30,140 lbs.
M1 Flatrack with MLRS Pods	28,265 lbs.
Total Specimen Wt.	143,405 lbs.
Buffer Car (four cars)	257,900 lbs.

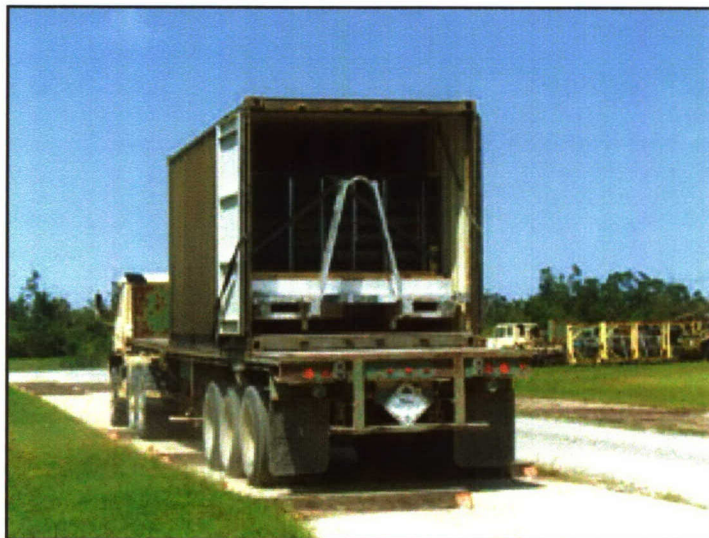
Photo 10. Hazard Course Testing of the JMIP

Pass No.	Elapsed Time	Avg. Velocity (mph)
1	25 Seconds	6
2	24 Seconds	6

1. Figure 17 lists the average speeds of the test load through the Hazard Course.
2. Inspection did not reveal any damage to the JMIP.

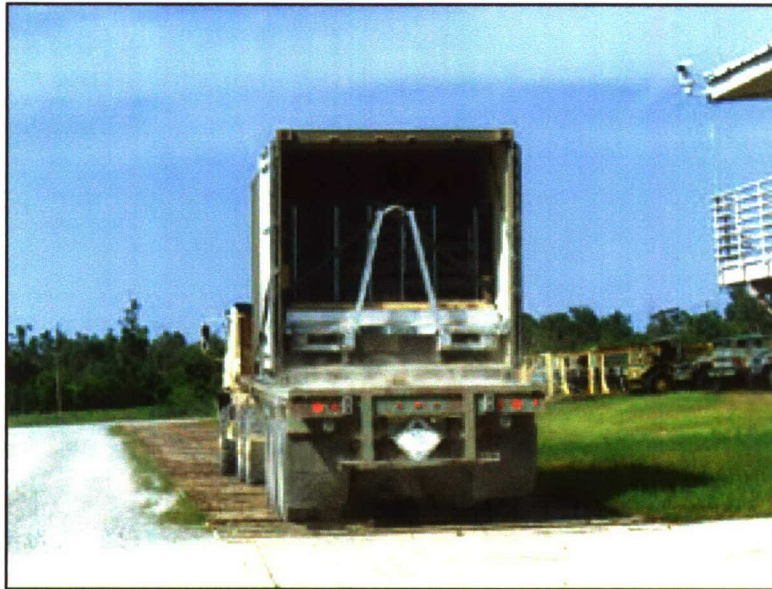
Photo 11. Washboard Course Testing of the JMIP

Remarks: Inspection following the Washboard Course revealed no damage to the JMIP.

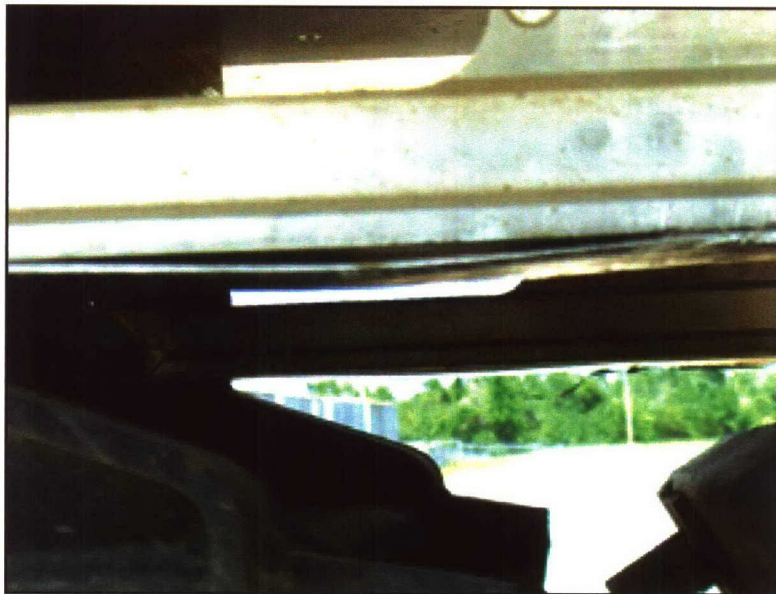
Photo 12. Deformation of Main Rail

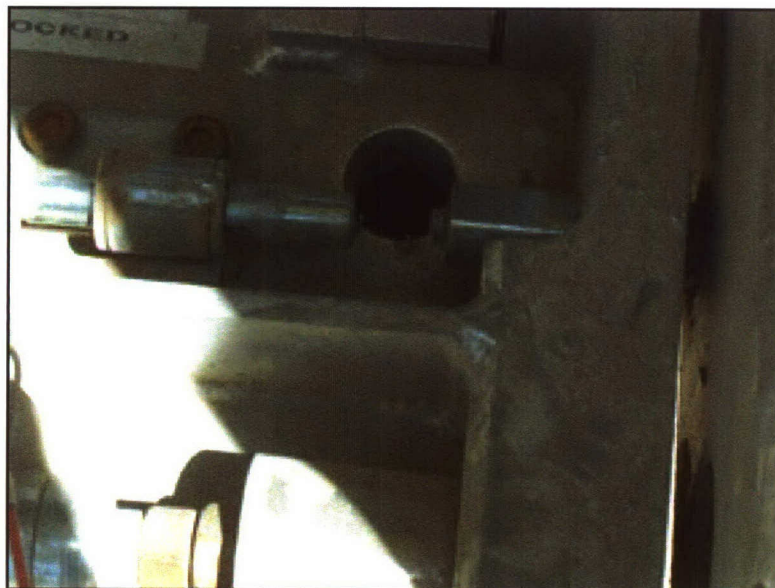
3. The pins that hold the A-frame in the container transport position both failed and sheared.

Photo 13. Damaged Container Transport Pin

The pins that hold the A-frame in the container transport position and that failed during testing were reported to have been manufactured incorrectly. The pins were replaced for follow-on testing (06-04G, 06-04H, 06-04J) and successfully completed testing.

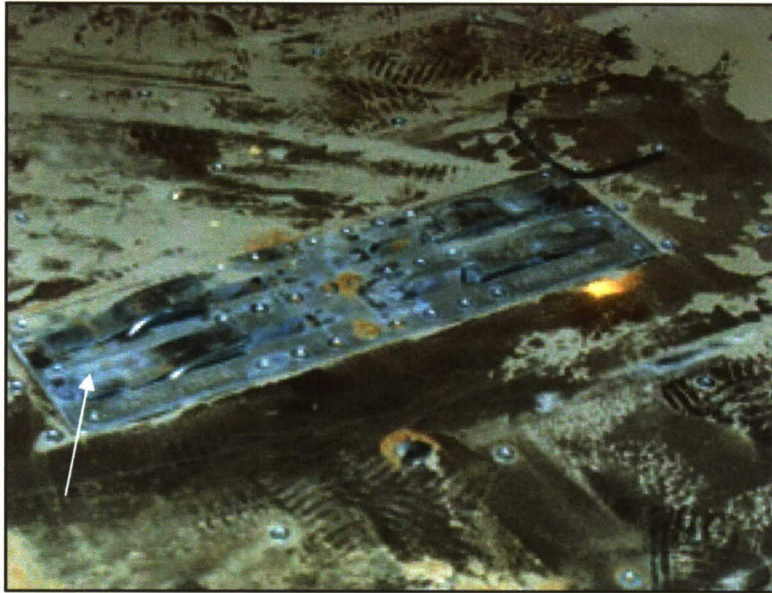
7. The spring steel around the JMIP to JMIP locks was damaged and deformed. Additionally, one (1) set of JMIP rings would not properly operate until the dirt was removed.

Photo 16. Damaged JM1C Lock Covers

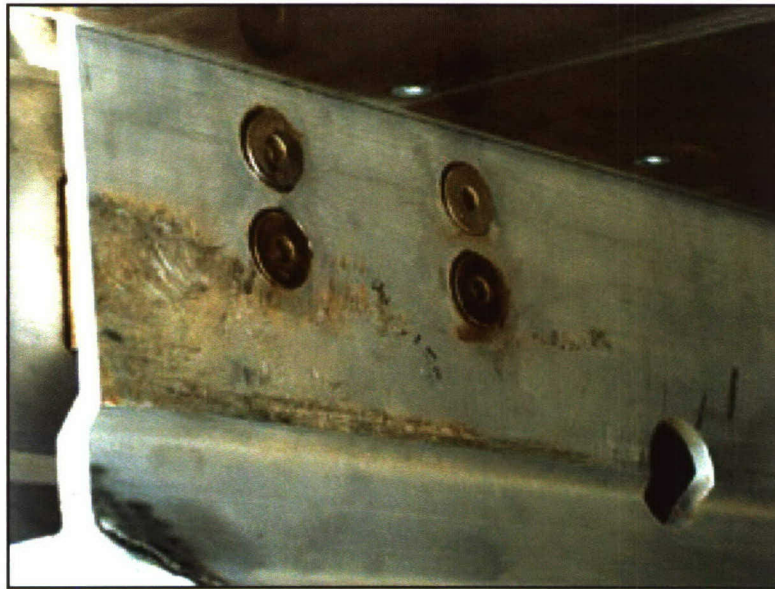
10. The hex head rivets on the top of the deck and along the main rail at the A-frame end were loose.

Photo 18. Loose Rivets

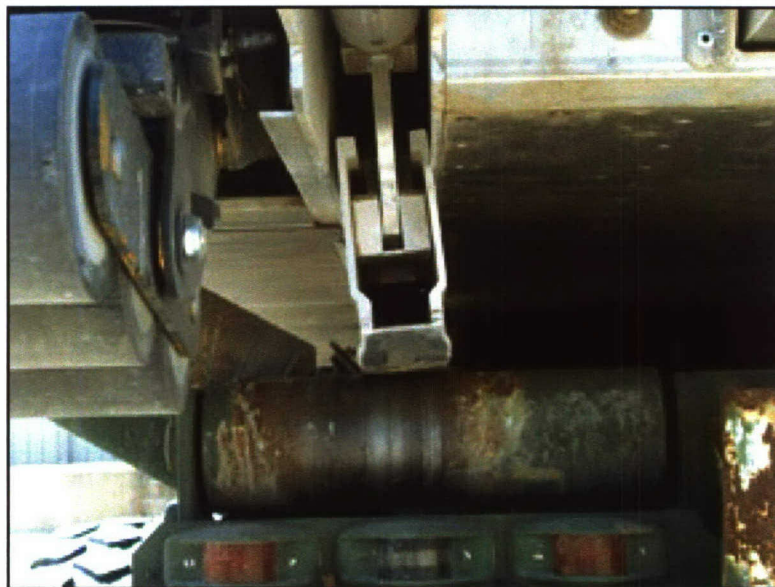
11. The JMIP rails were bowing in following extraction of the JMIP from the intermodal container onto the PLS truck.

Photo 18. Bowing of JMIP Rails
